# REPORT

REPORT NO. 100523794CRT-001

TEST OF A FLASHLIGHT, MODEL: 3765

PELICAN PRODUCTS  
23215 EARLY AVENUE  
TORRANCE, CA 90505

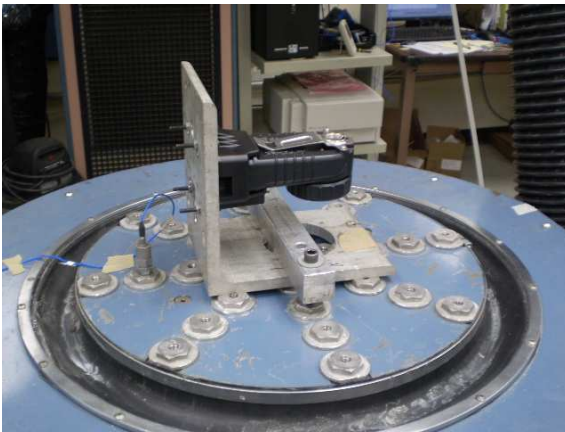
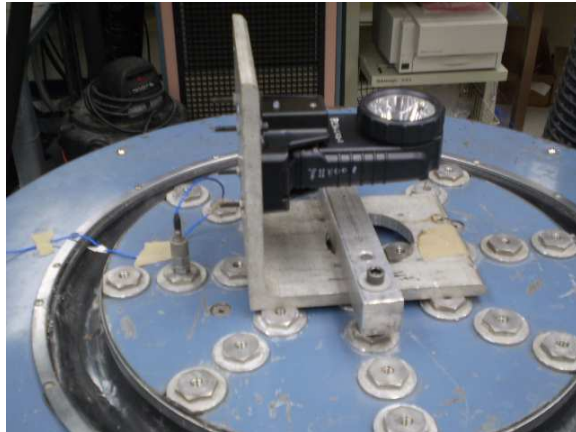
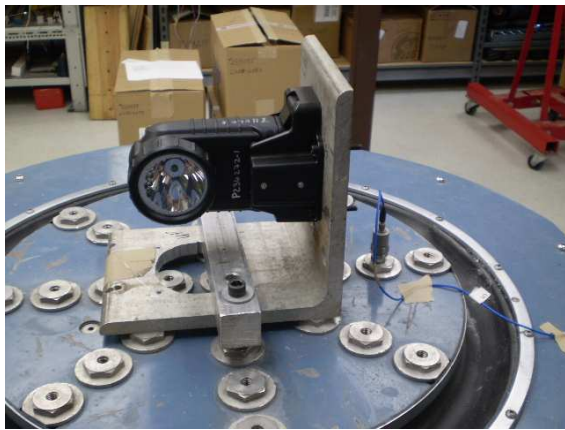
TEST OF A FLASHLIGHT, MODEL: 3765  
TESTED FOR PELICAN PRODUCTS.

Attachment: Picture page.  
Mechanical shock plot page.
